Title: Mosler versus the Atom: How safe is a safe.

Mosler versus the Atom How safe is a safe?

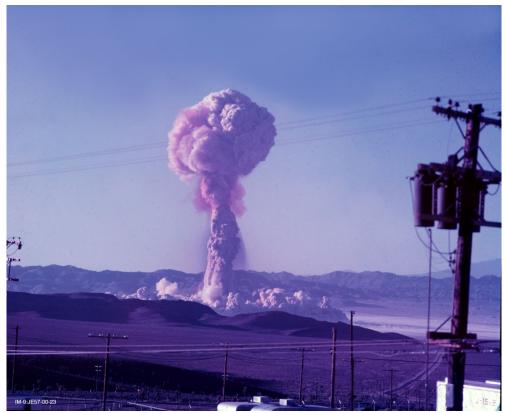
Priscilla

On June 24, 1957, a thirty-seven kiloton nuclear device, codenamed Priscilla, exploded over the Nevada Test Site's Frenchman dry lake. Under the direction of the Federal Civil Defense Administration, a bank vault designed by the Mosler Safe Company of San Francisco, was placed at the projected 75 psi line "to evaluate the effectiveness of a reinforced-concrete vault and steel vault door in providing protection against the effects of a nuclear detonation."

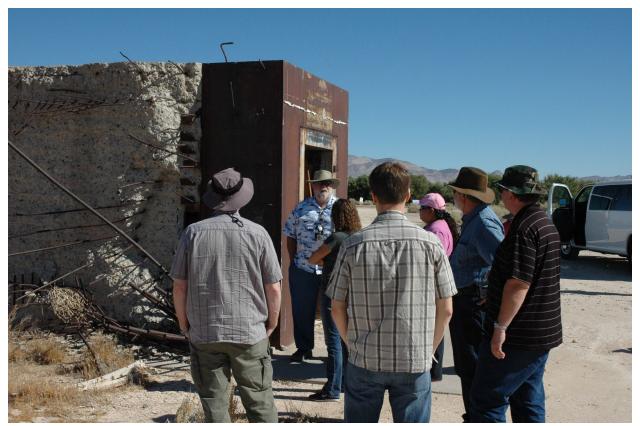
Bank Vault 2011

Blast damage to the exterior was largely confined to the side walls, whose concrete was stripped off and some very large chunks thrown more than eighty feet away. The steel reinforcing rods were bent and twisted. The vault door was essentially undamaged and was opened with minimal difficulty.⁴ The condition of the interior is described below.

The vault contents were only slightly disturbed by the blast. The sandbags against the front wall were shifted a few inches toward the rear of the vault. The movie camera, mounted on a tripod attached to the floor lining by three machine screws, was tilted upward approximately 10 degrees from its original position. The camera operated as planned, running 40 ft of film. The developed film was completely fogged. The two clinical type thermometers registered 88°F, and the 24-hr stylus American temperature recorder showed no variation in temperature from H-6 hr through H-18 hr, remaining constant at 88°F. The Leeds and Northrup thermocouple recorder ran 20 min, but the
